Manhole Inspection Summary

Manhole # S55S__014MH

Insp Date: **5/27/09 8:10 AM**

Location Address: **1501 S HIGHLAND AV**

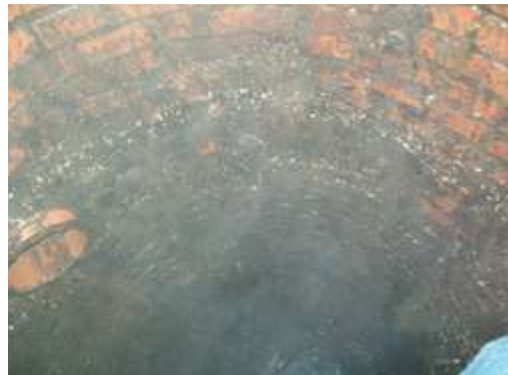
MISC.

SURCHARGE PEAK LEVEL EVIDENCE

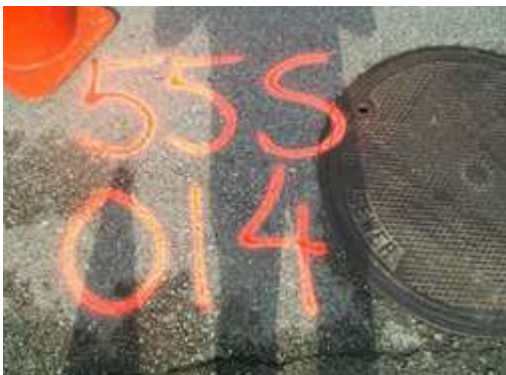
MISC.

PAVEMENT MARKED

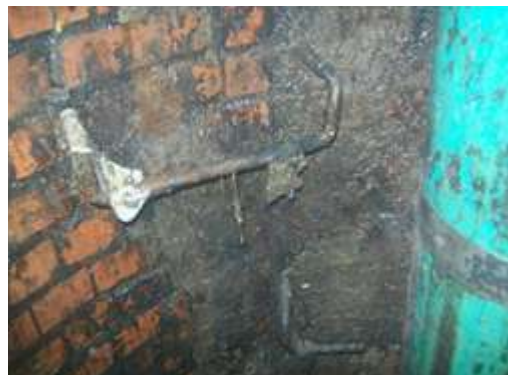
Defect 2

☒ **Evidence Of Surcharge** Depth: **8** (ft.) ☐ Active Surcharge Present

EVIDENCE OF SURCHARGE

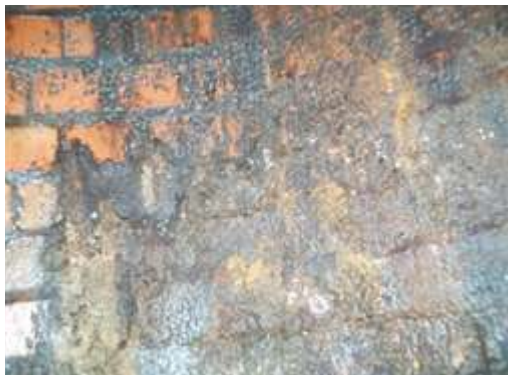
Defect 1

Infiltration: ☐ None ☐ Joint ☐ Cracks ☐ Mortar ☐ Roots ☒ **Wall**

INFILTRATION @ BARREL WALL

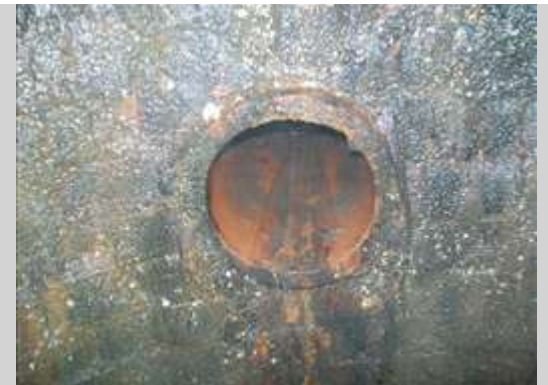
3 O'Clock Inflow

Pipe Height: **8.4** (in.) Rod and Bar (Angled)
Pipe Material: **Clay** ☐ Pipe Lined
Invert Depth: **10.76** (ft.) Flow Characteristics: **Slow**
Deposits: ☒ None ☐ Mud ☐ Sludge ☐ Debris ☐ Grease
Silt Depth: **0** (in.) Deposits Extent:
Infiltration: **None** Pipe Seal Cond: **Unknown**

Drop: **Outside** Rod and Bar
Angled: **Yes** Reading: **21.88** (ft.)
Inv Depth: **22.88** (ft.)

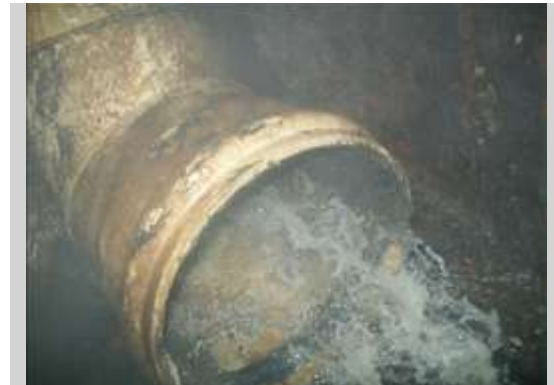
Drop In @ 9 O'Clock

Drop: **Inside** **Rod and Bar**
Angled: **Yes** Reading: **21.80** (ft.)
Inv Depth: **22.80** (ft.)
Drop Condition: **Open**
